Situation Photo Log

Tuesday, May 1, 2012

Kalamazoo River / Enbridge Spill

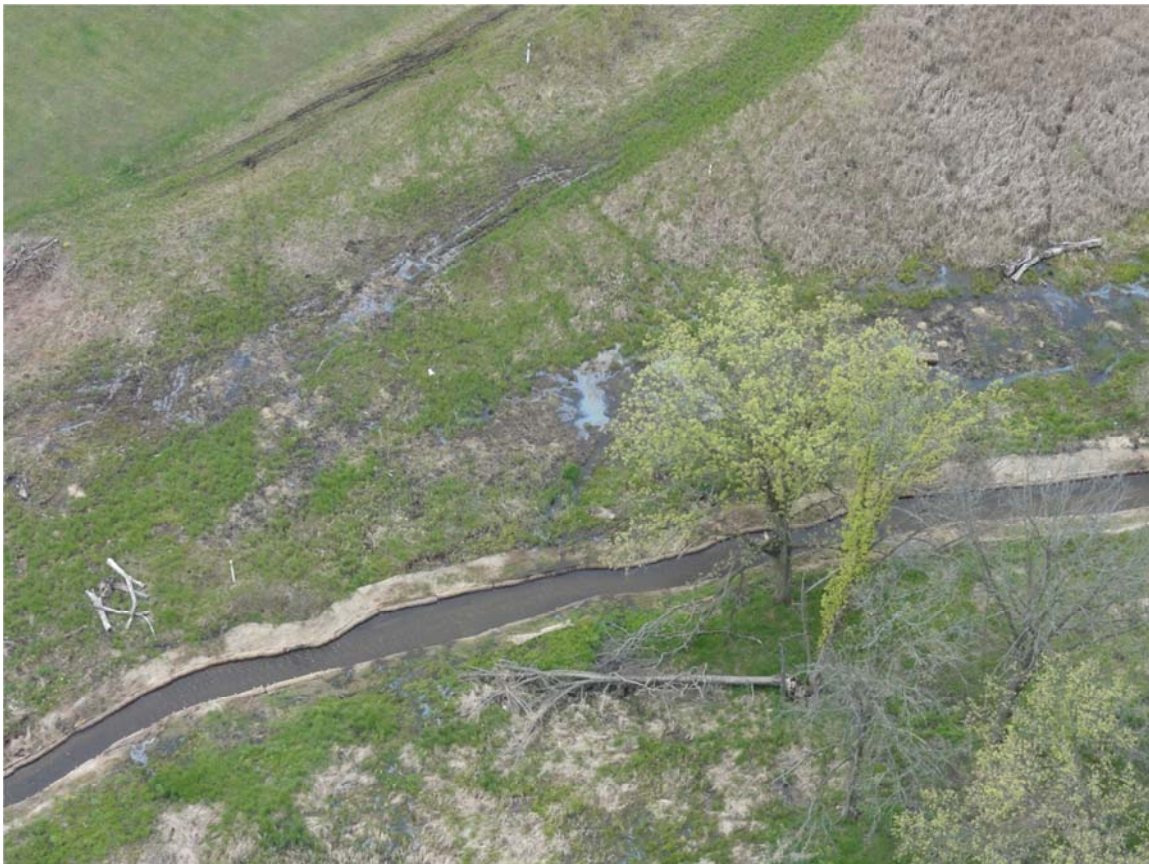
1. Talmadge Creek, MP0.75 LDB sheen observed.

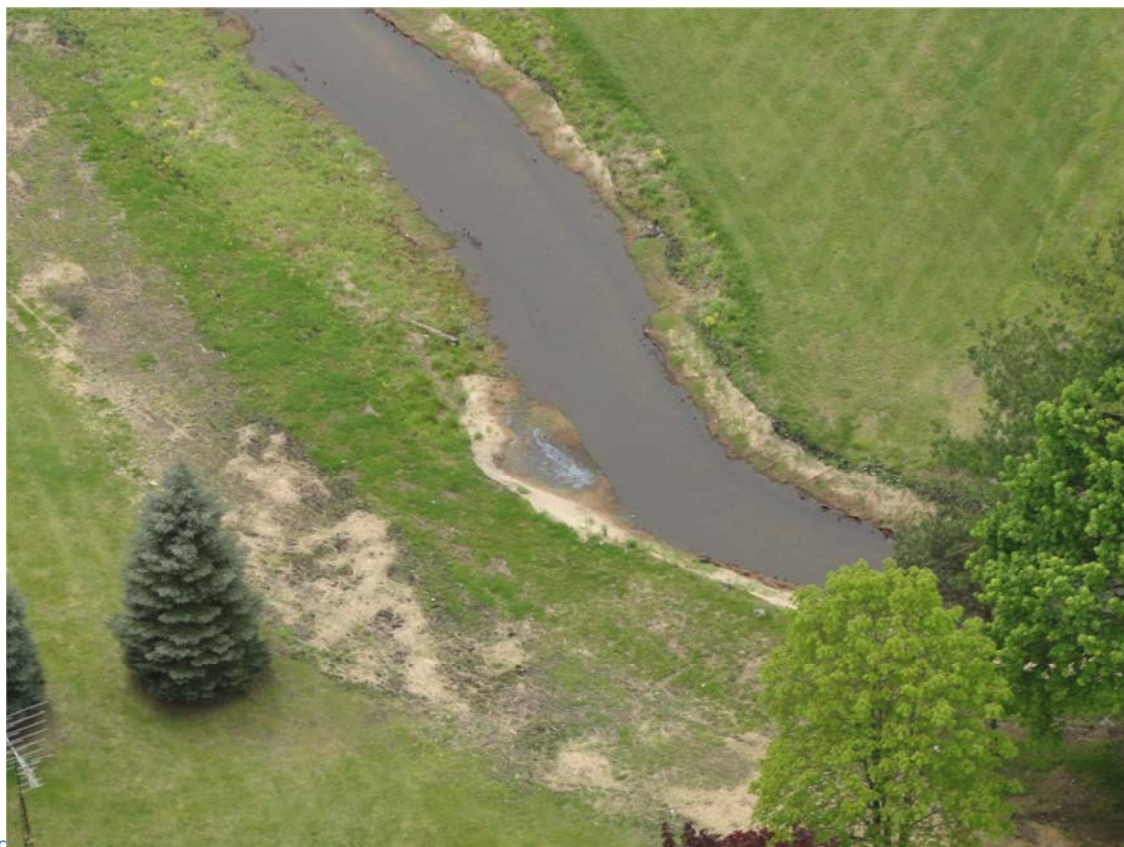
2. Talmadge Creek MP1.10 RDB sheen observed.

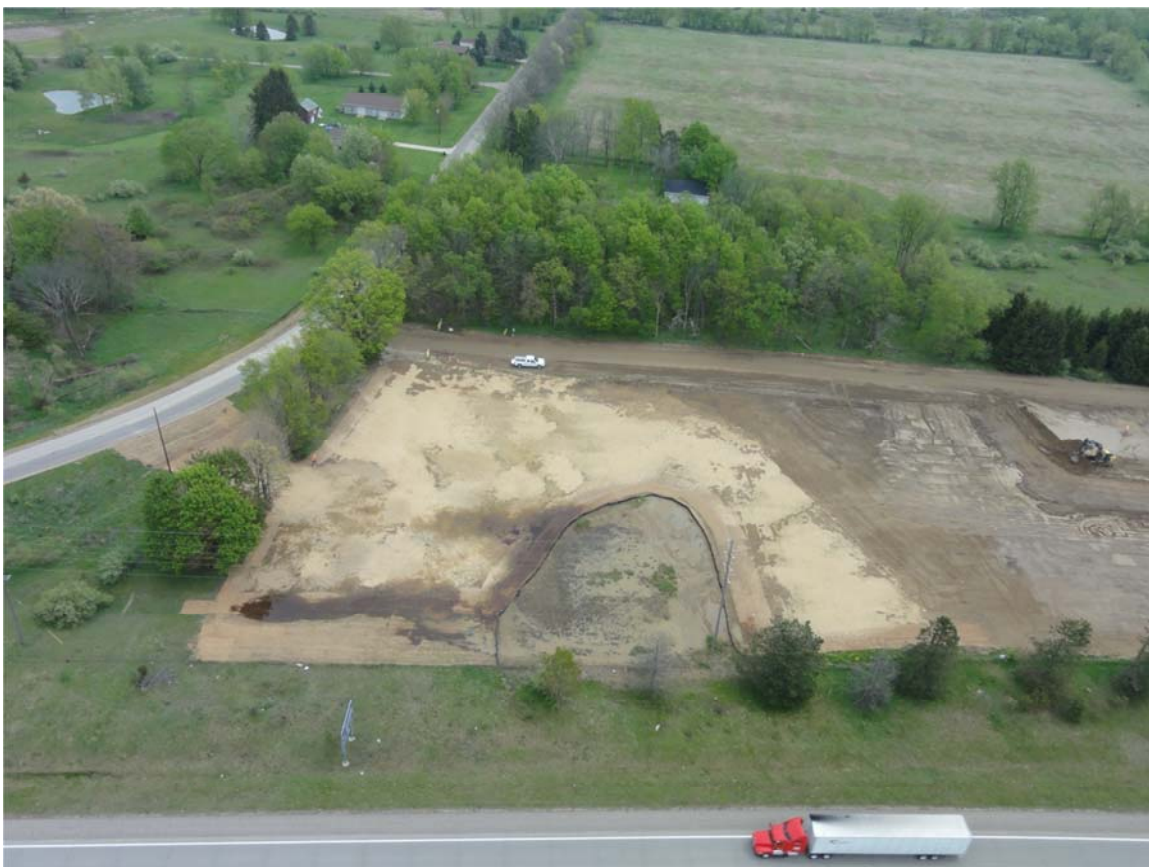
3. Frac-City footprint reduction work continued.

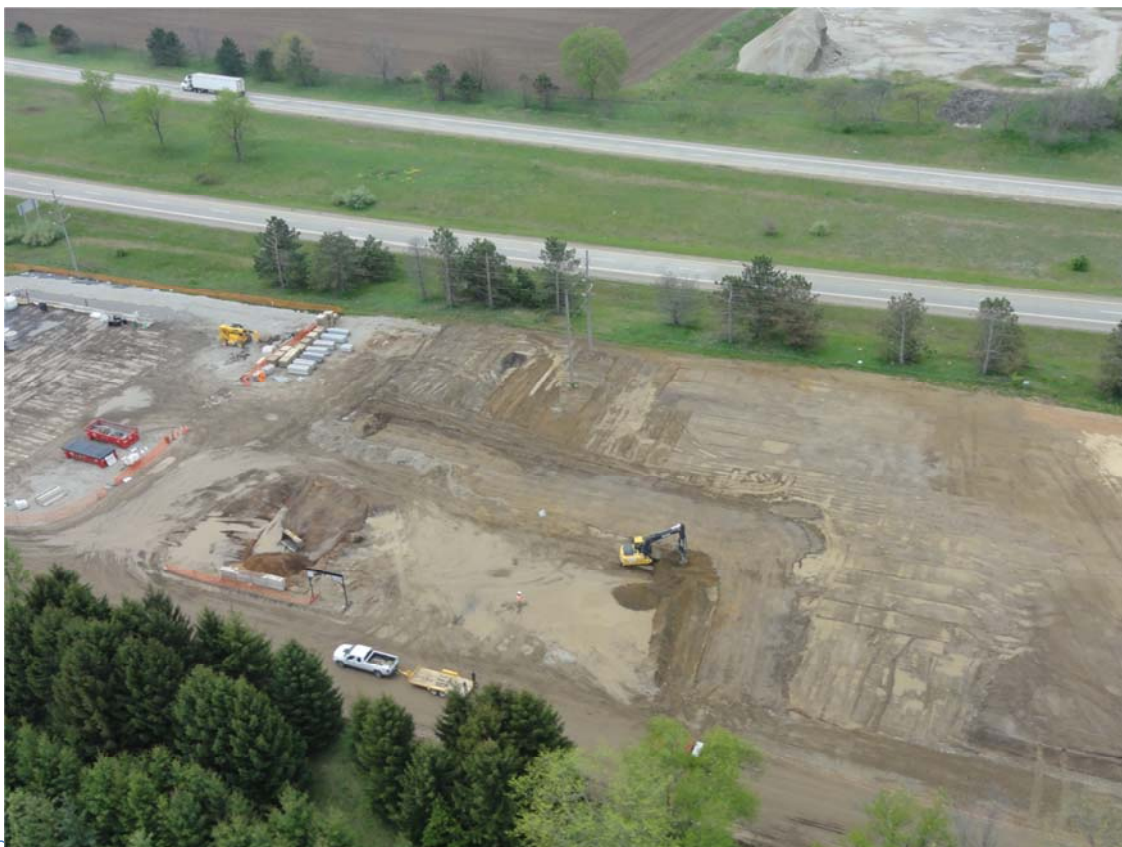
4. Frac-City footprint reduction work continued.

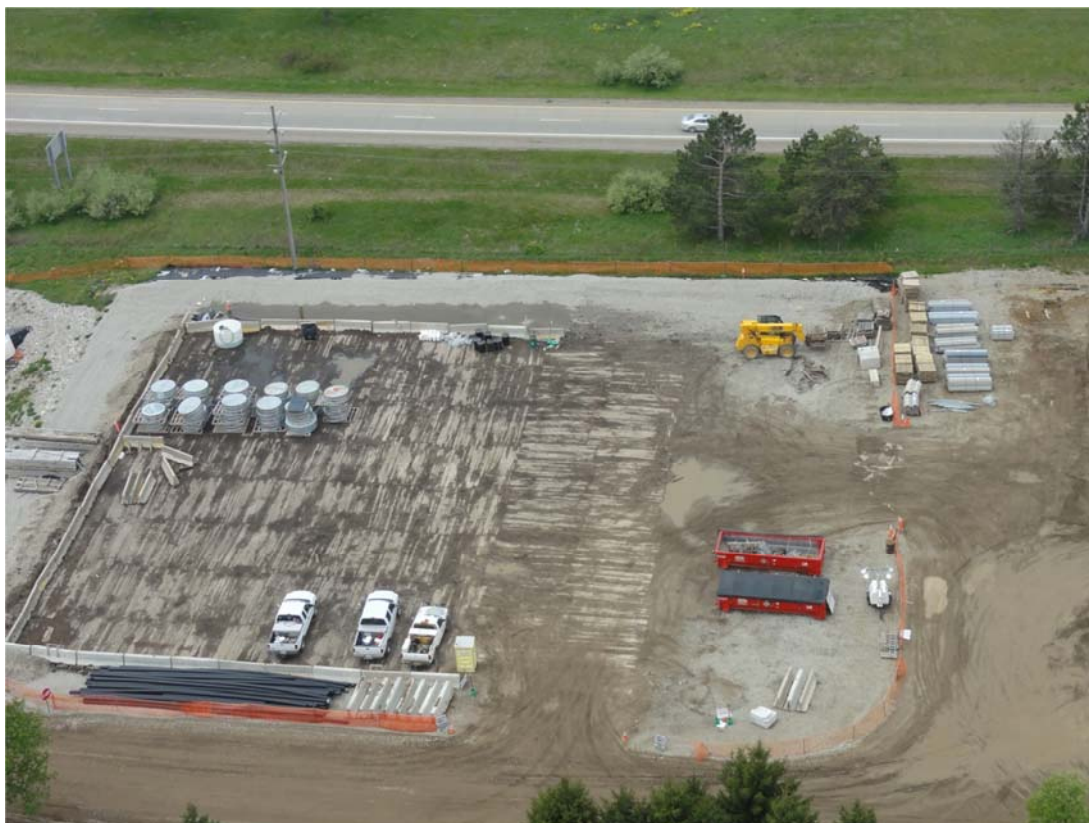
5. Frac-City footprint reduction work continued

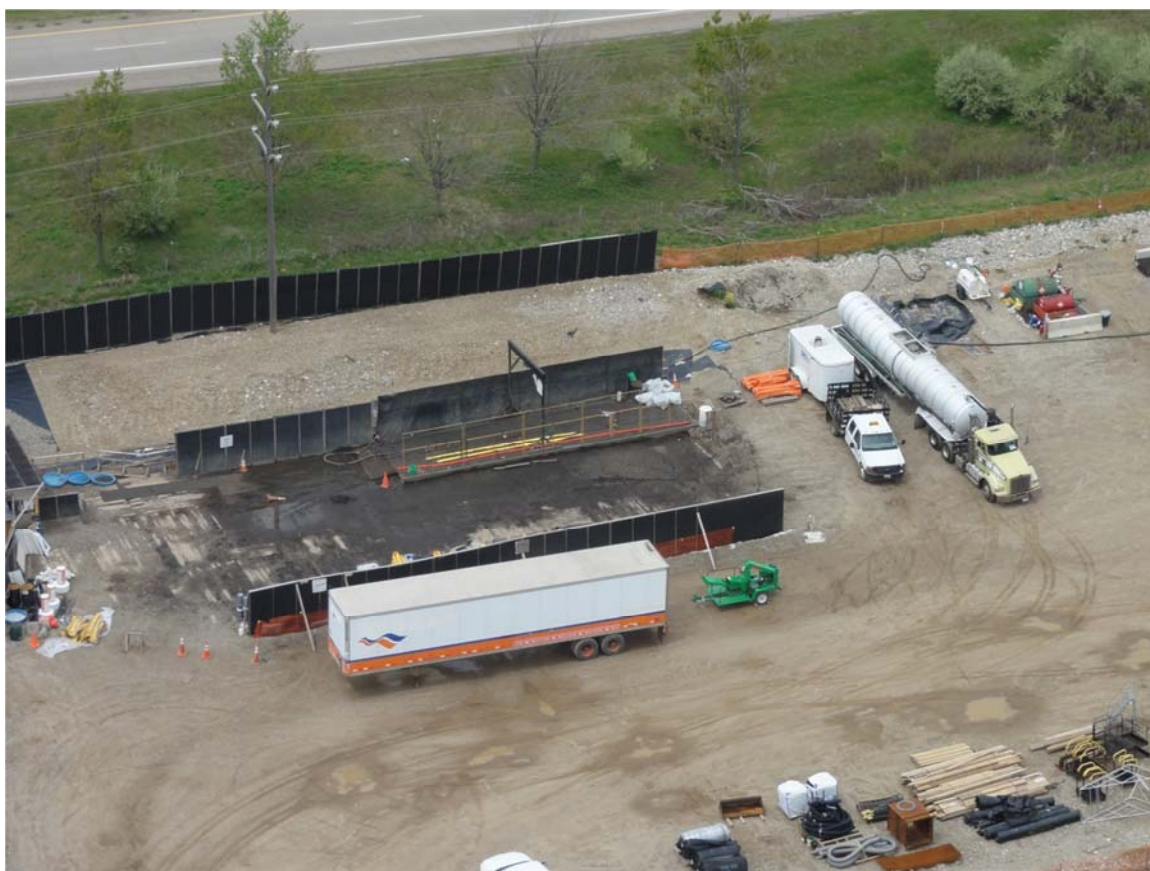
6. Frac-Tank City, vacuum truck observed.

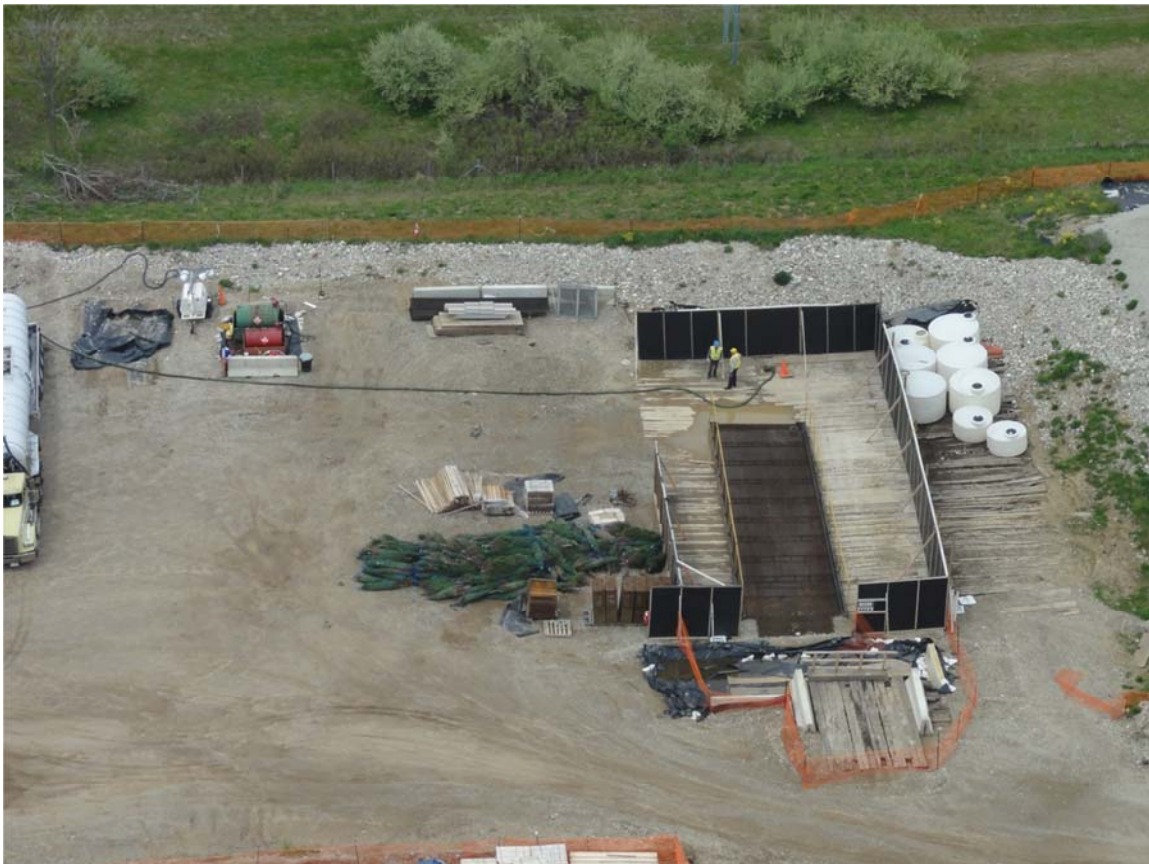
7. Frac-Tank City, conifer trees staged.

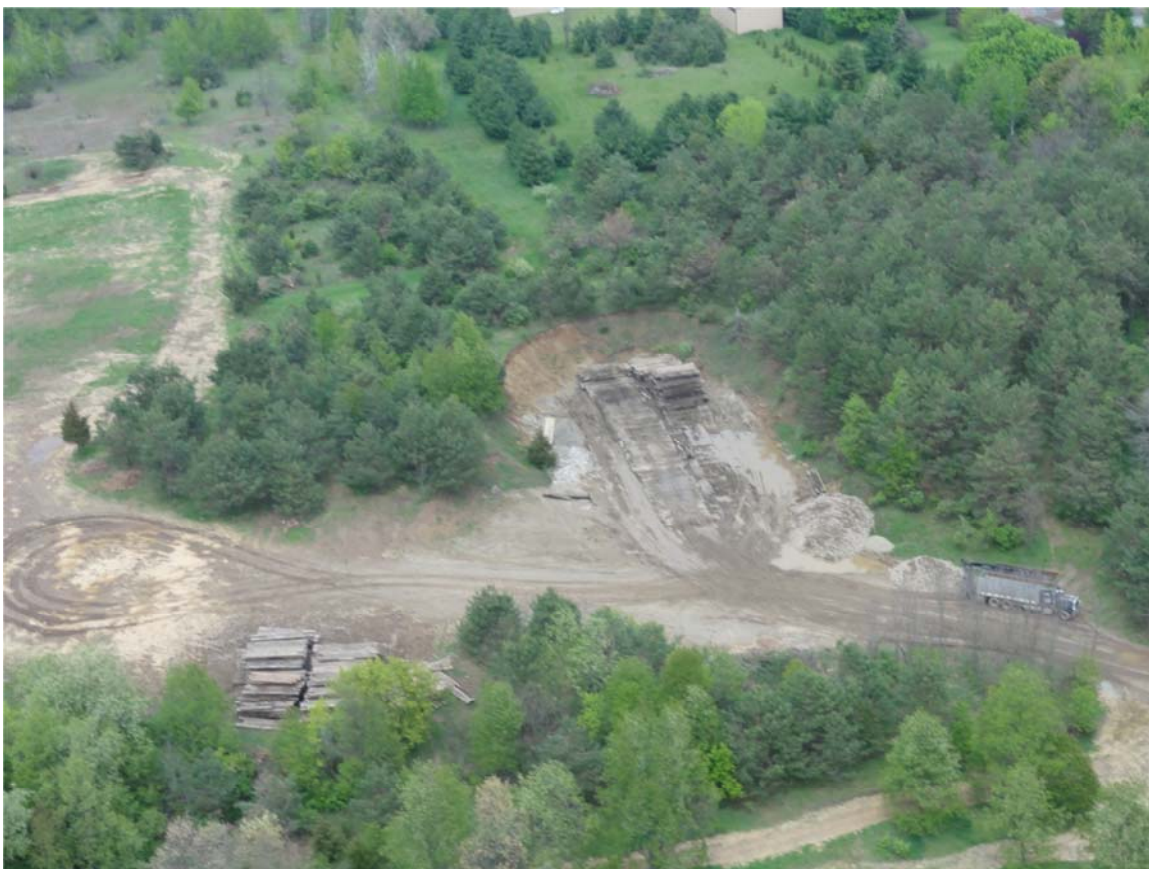
8. Staging area off 15 1/2 Mile Road.

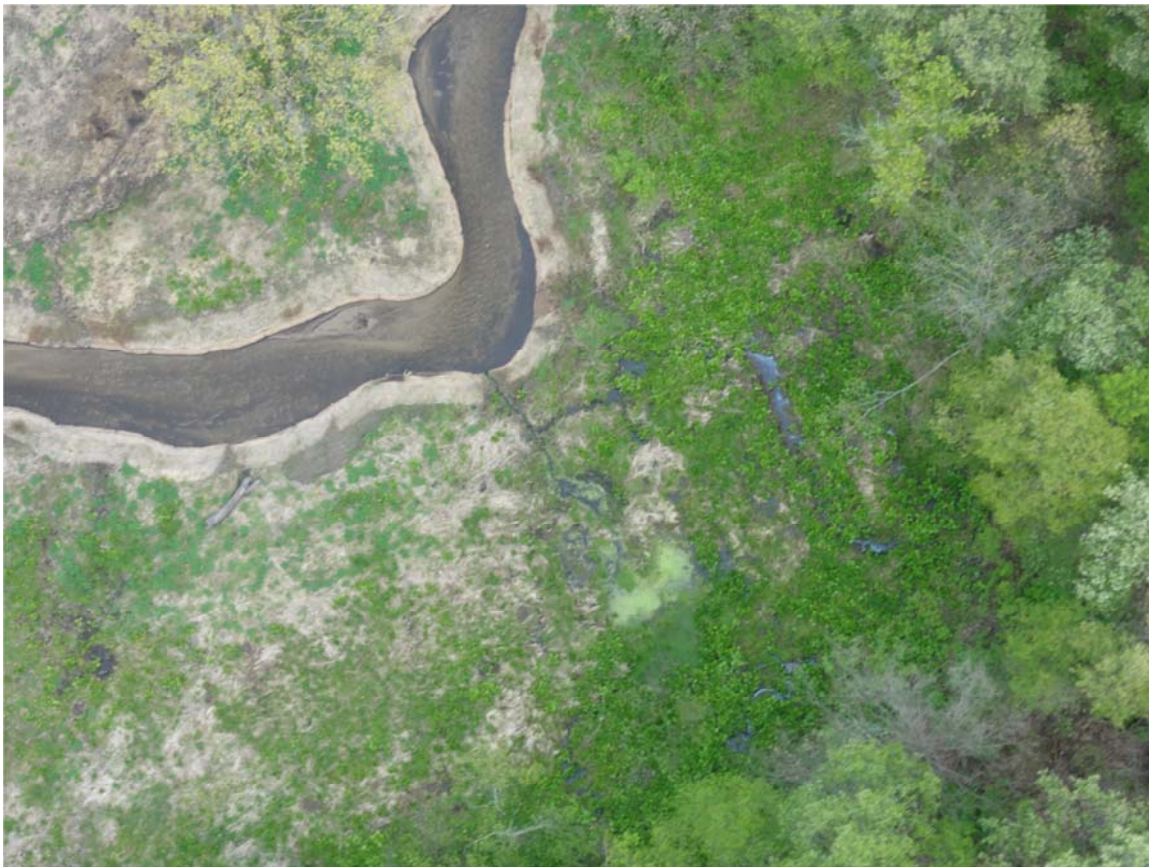
9. MP1.65 Talmadge Creek LDB sheen observed.

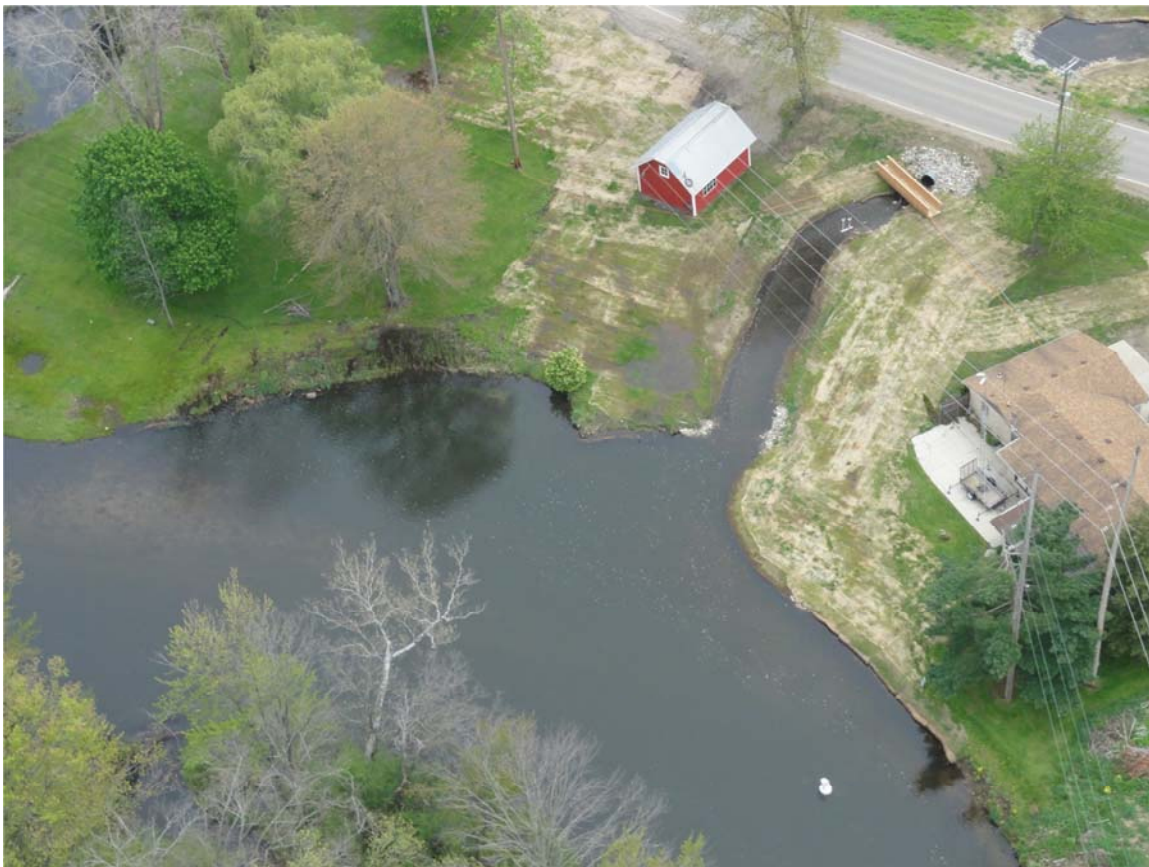
10. Confluence, no turbidity observed.

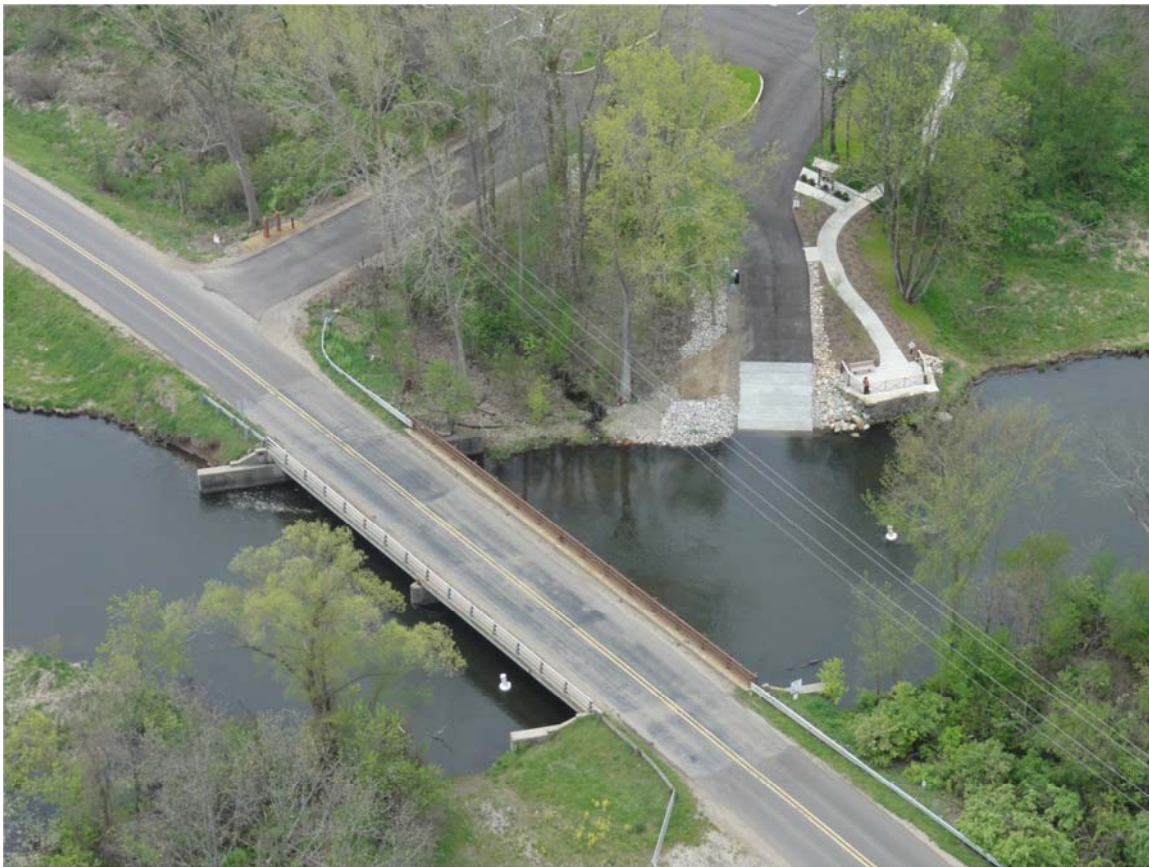
11. Saylor's Landing. No public activity observed.

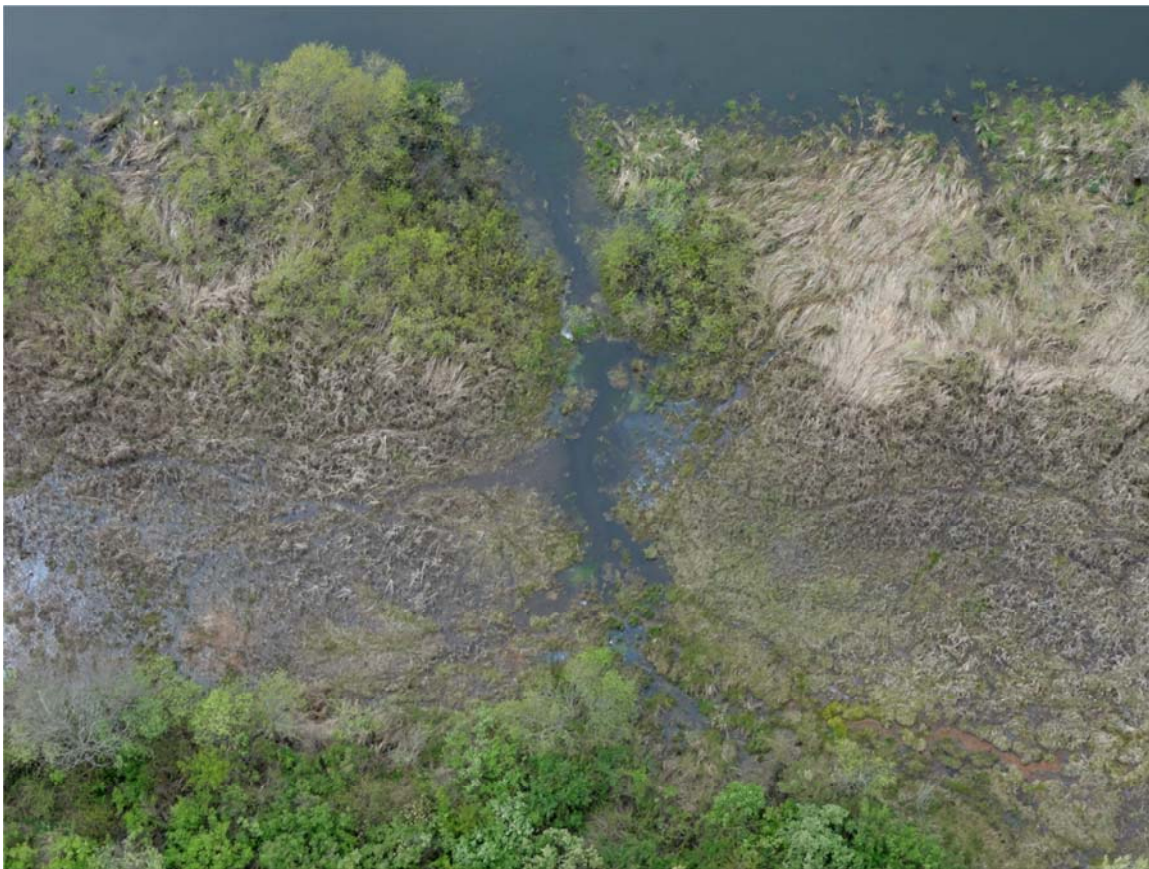
12. MP5.5 RDB sheen observed.

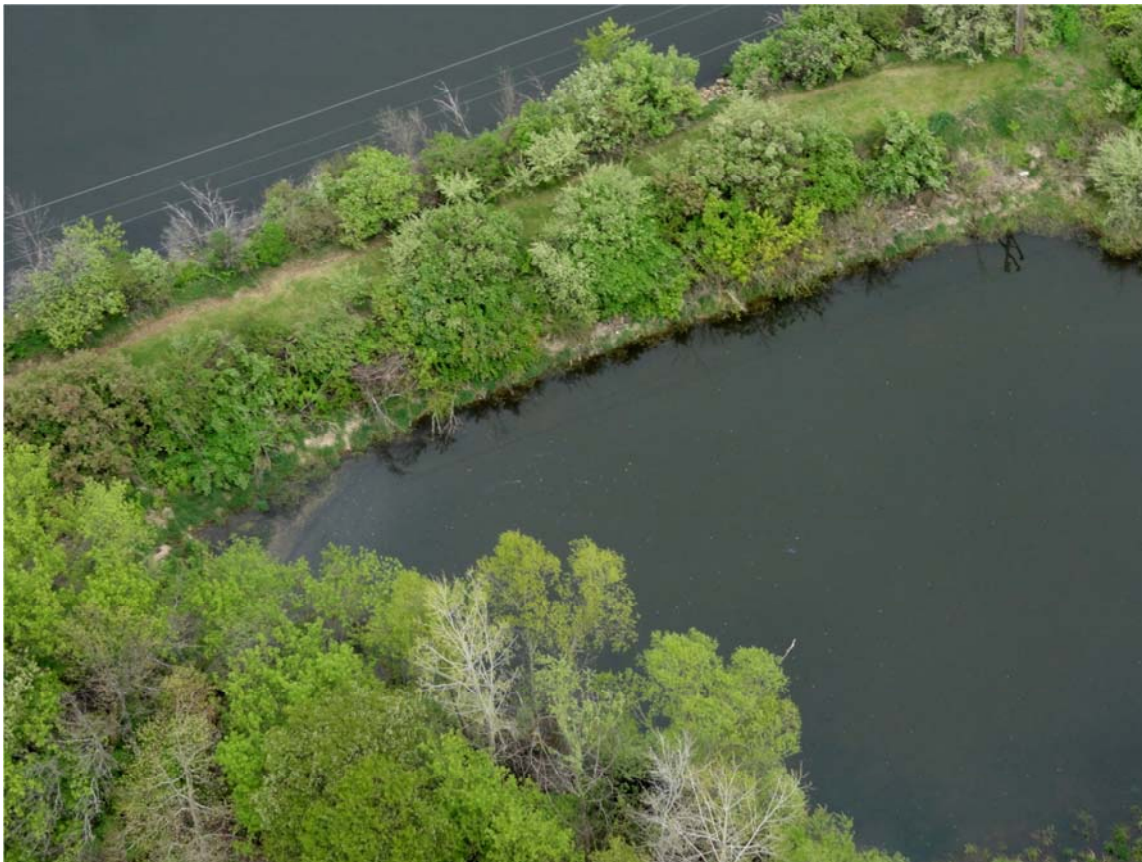
13. MP5.75 LDB sheen observed.

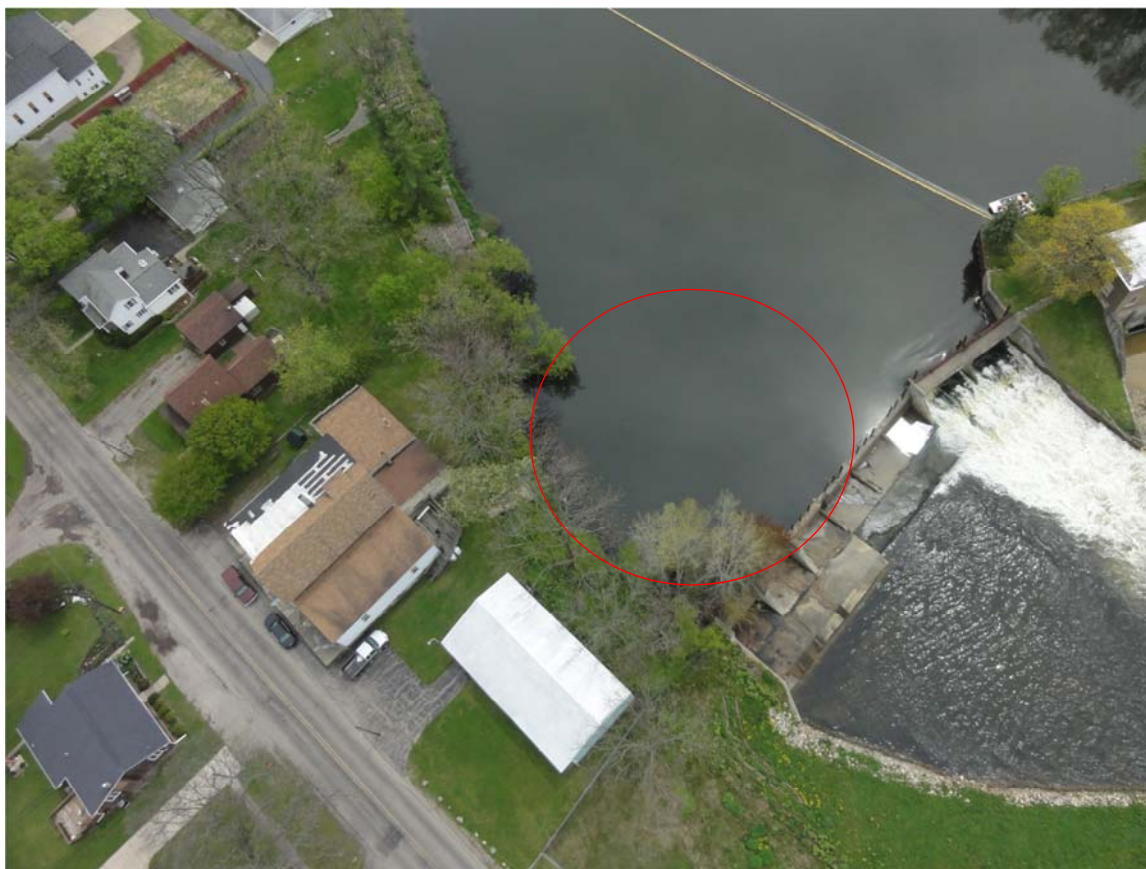
14. Sheen observed along the north bank above Ceresco Dam.

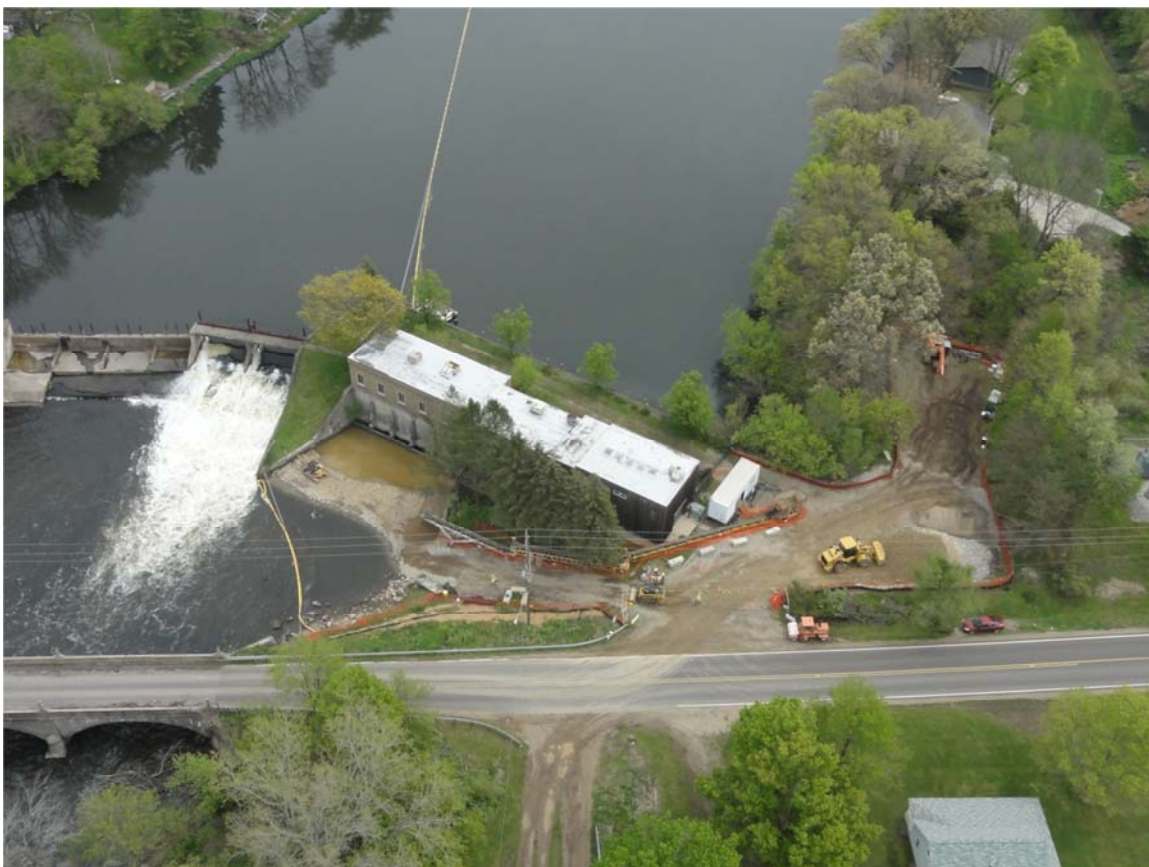
15. Ceresco Dam legacy work continued.

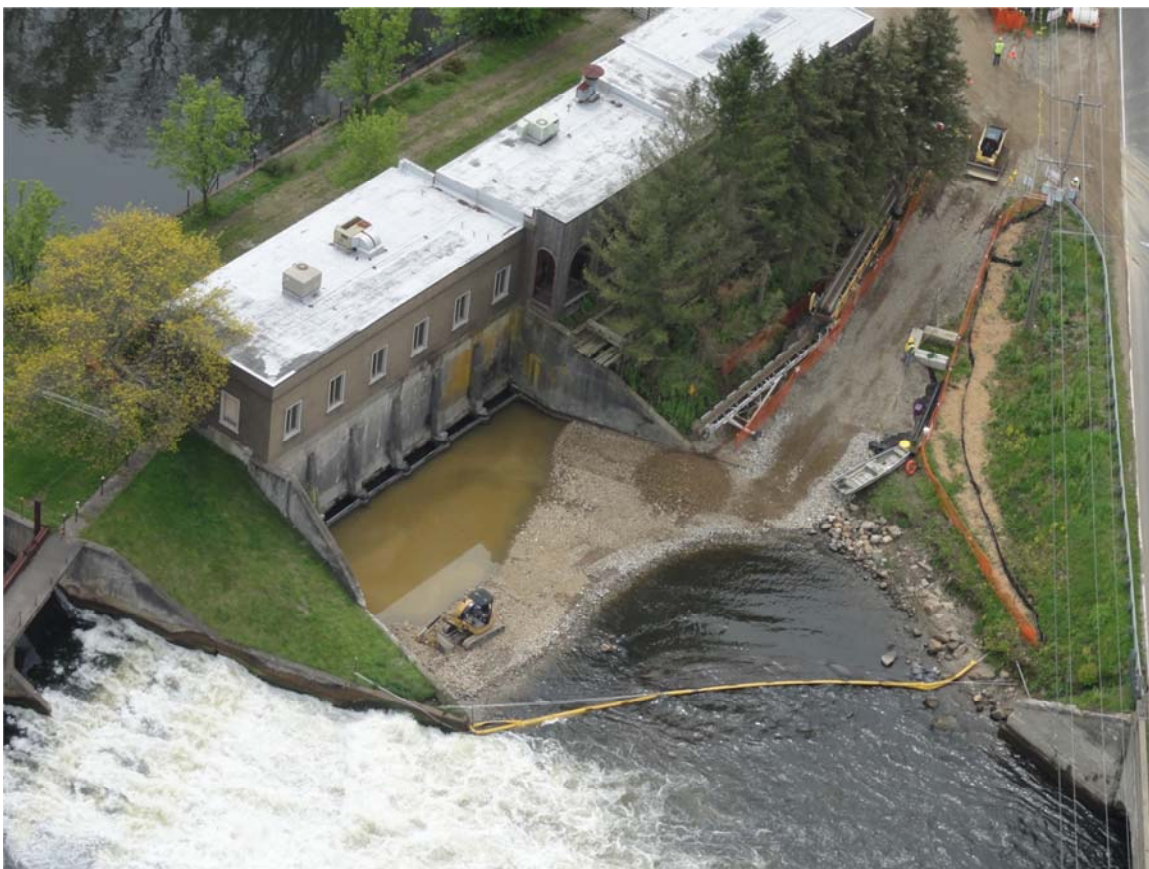
16. Ceresco Dam legacy work continued.

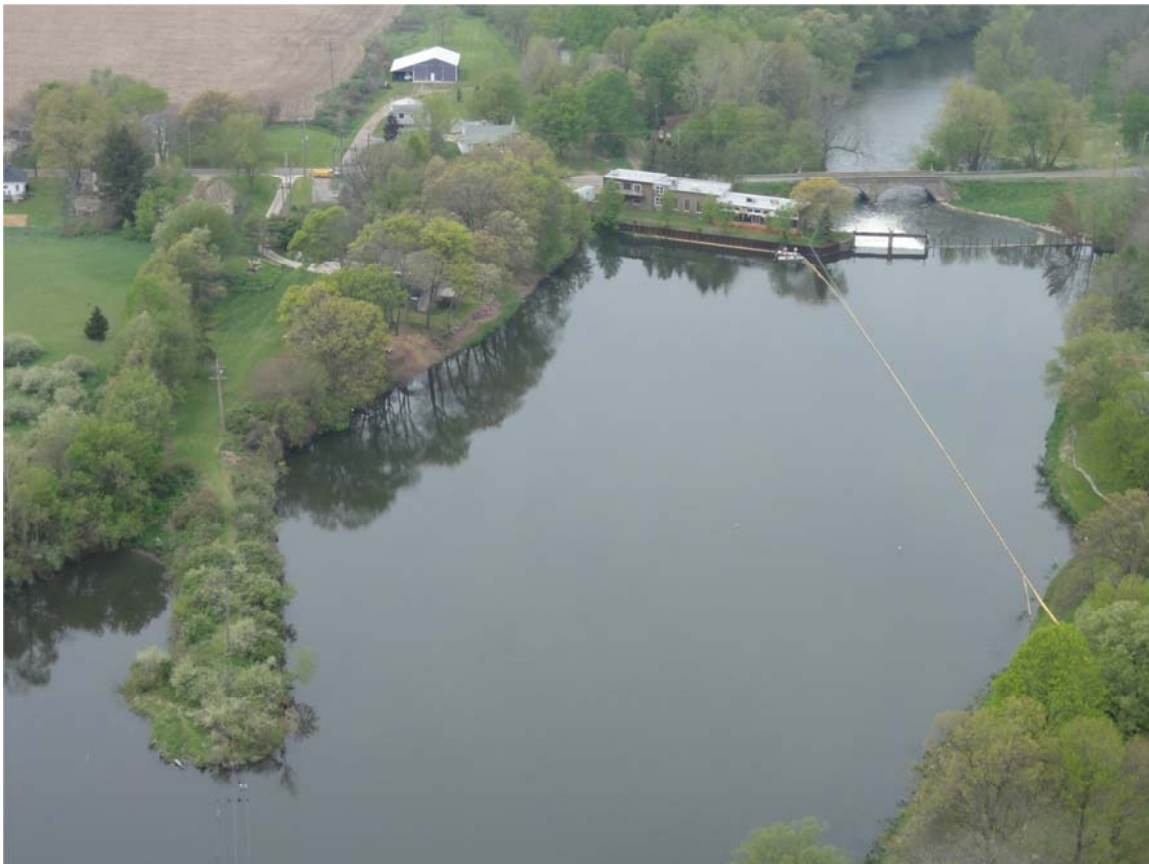
17. Ceresco Dam boom reconfigured.

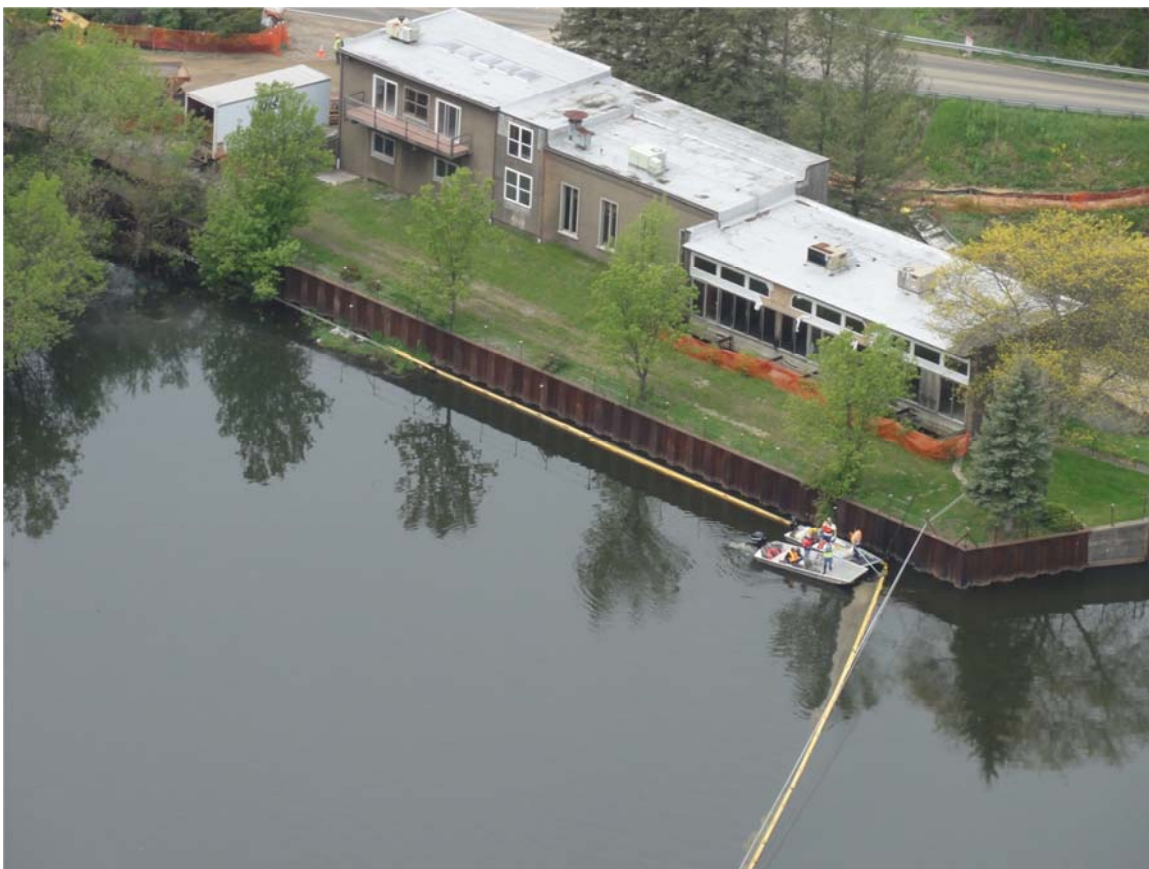
18. SWAT crew observed performing boom maintenance at Ceresco Dam.

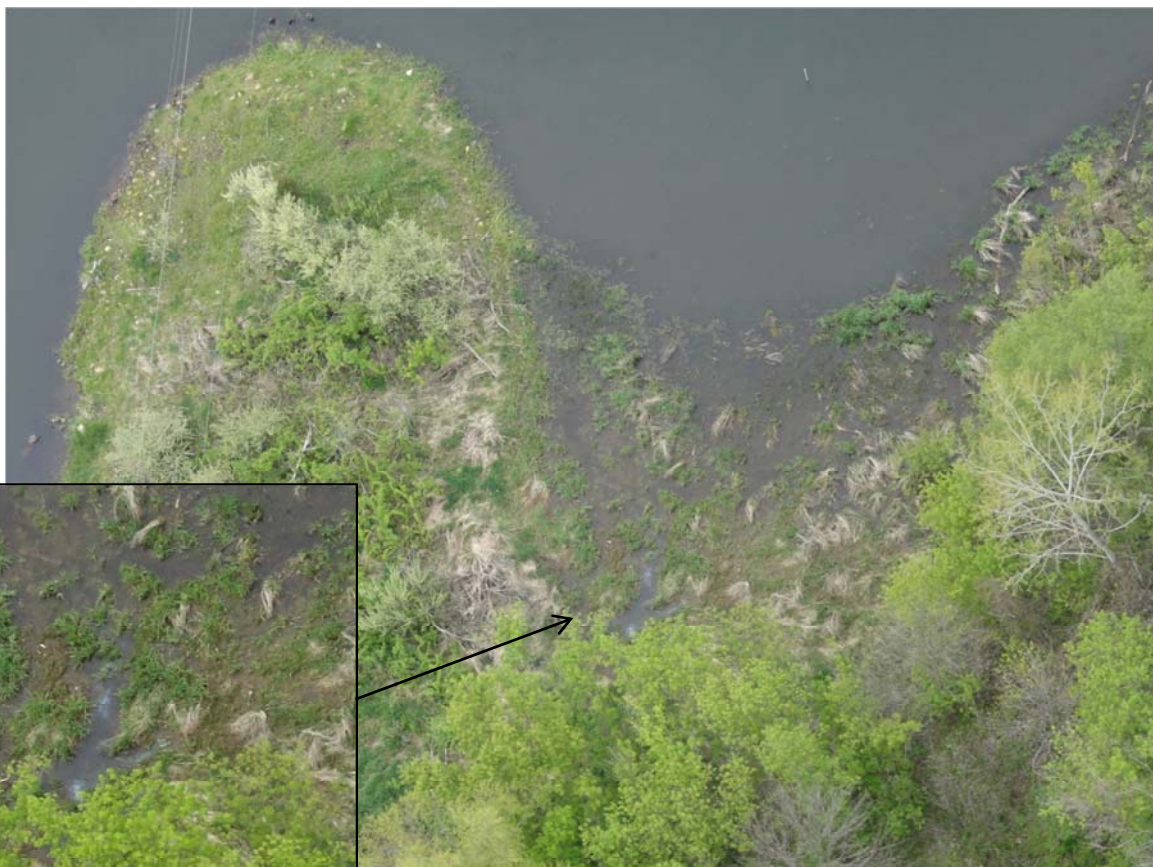
19. MP5.65 RDB sheen observed.

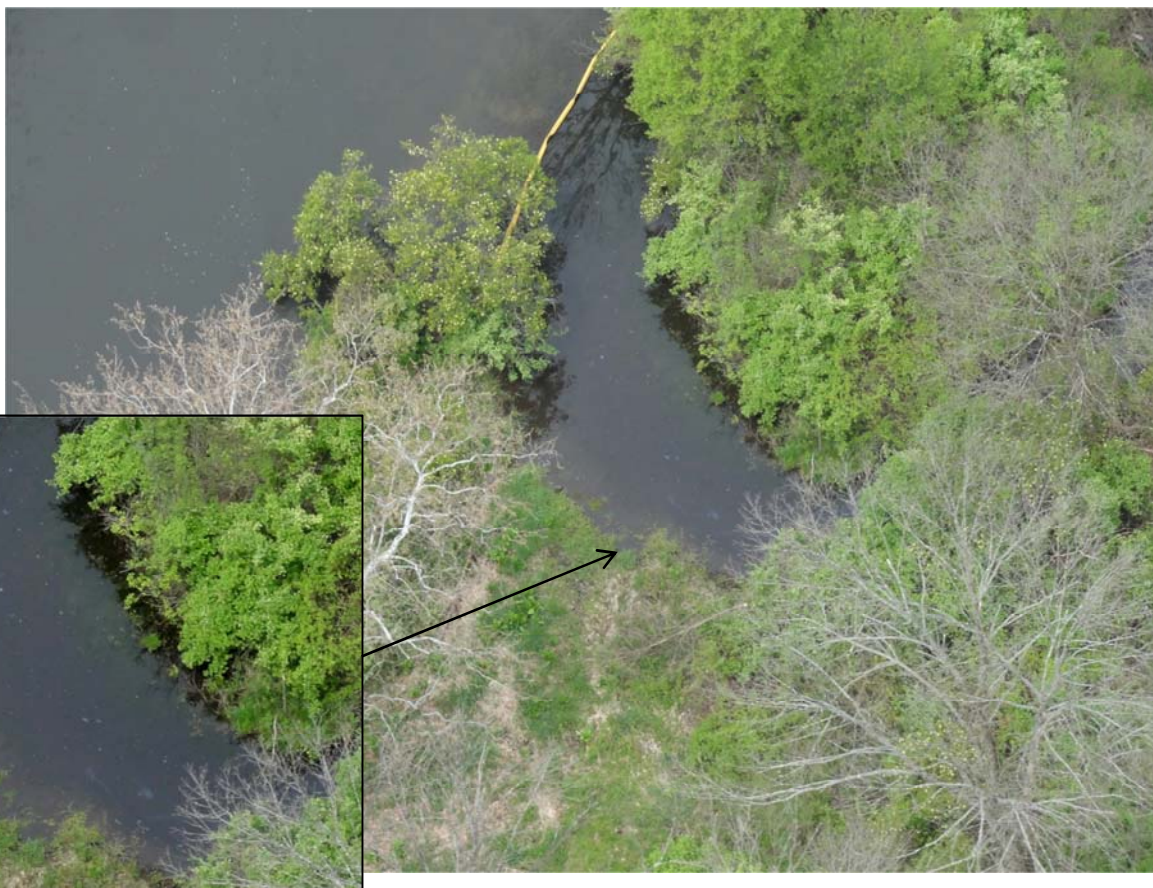
20. MP8.48 RDB sheen observed within boom.

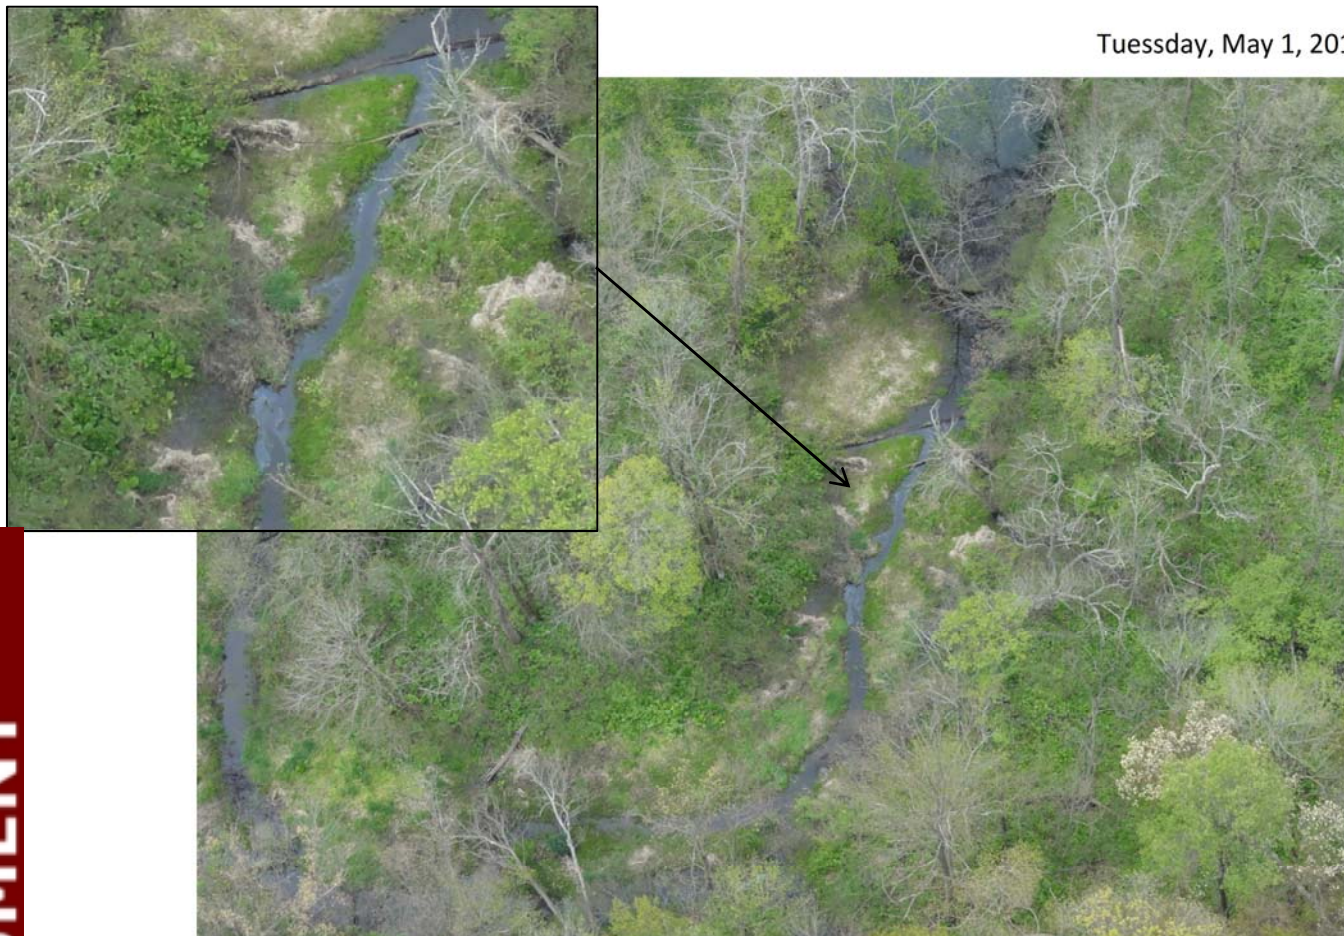
21. MP8.91 RDB sheen observed.

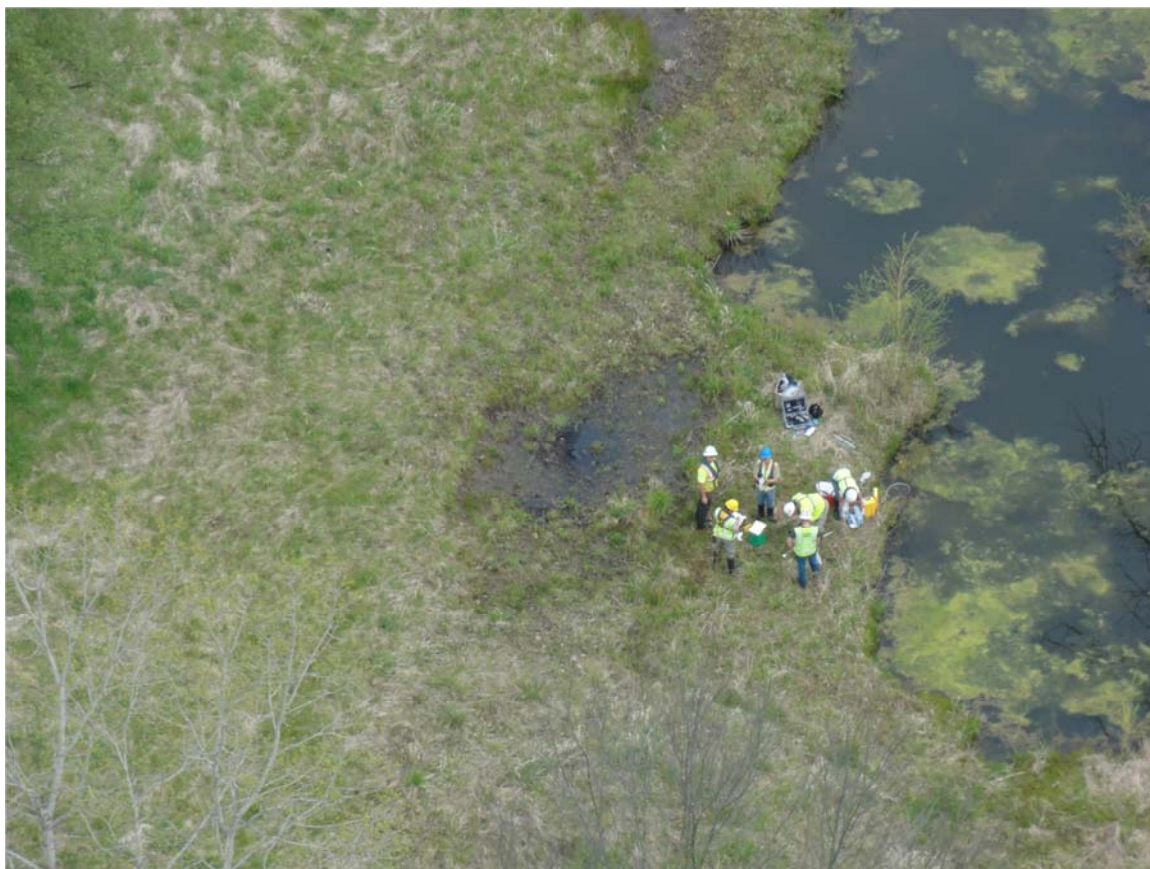
22. MP10.0 RI crew observed.

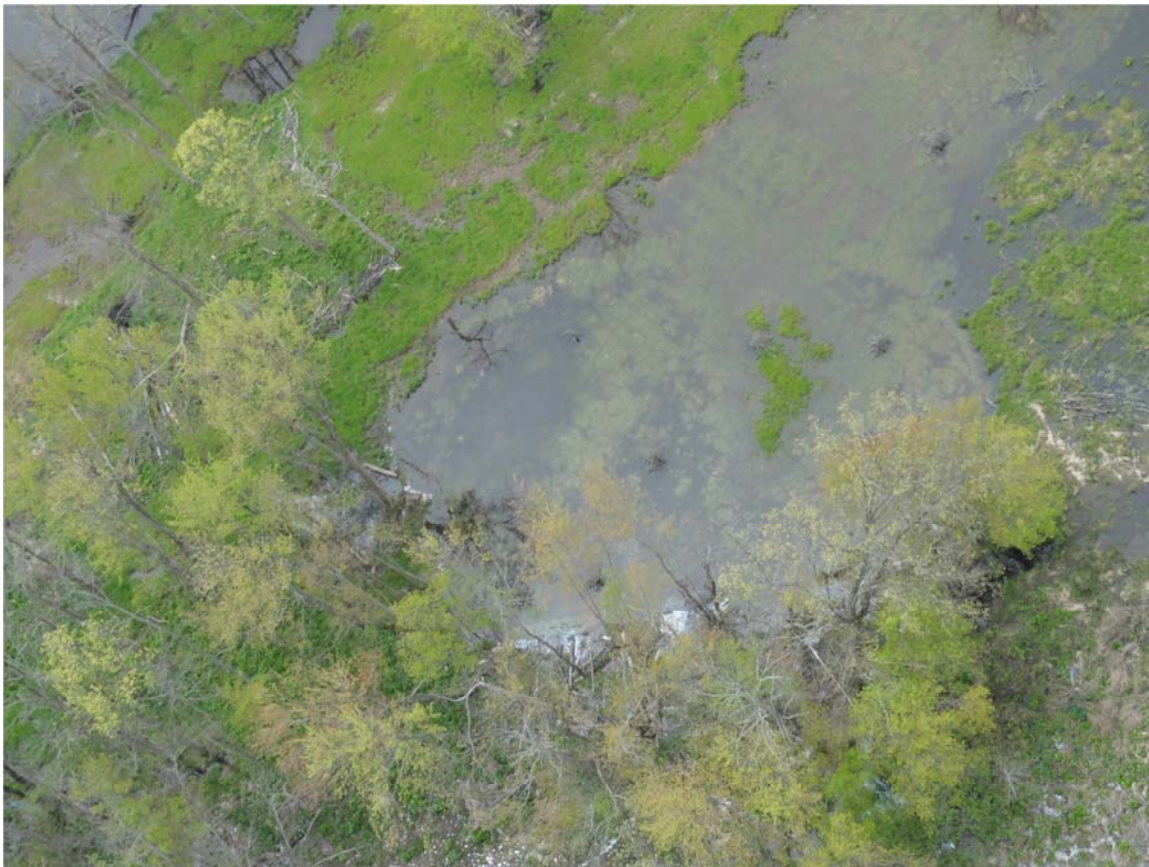
23. MP11.25 R2 sheen observed.
